# Efficacy and Application Areas of «**RIKOR**» Series Diffractometer

## Efficacy of Using ‘**RIKOR**’ Series Diffractometer in Manufacturing Parts and Facilities

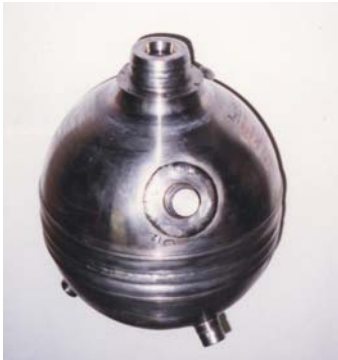
Part of satellite

**Purpose of check** – to assess stress condition in semi-spheres of satellite part at different state of their manufacture: before the flanges are welded in (operation 1), after the flanges are welded in (operation 2), and after thermal processing (operation 3).

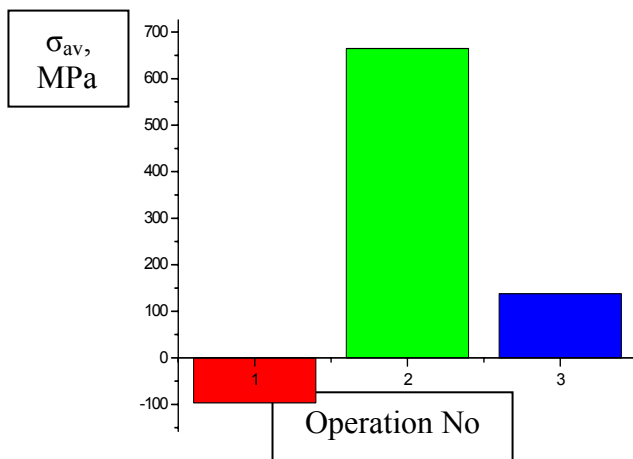
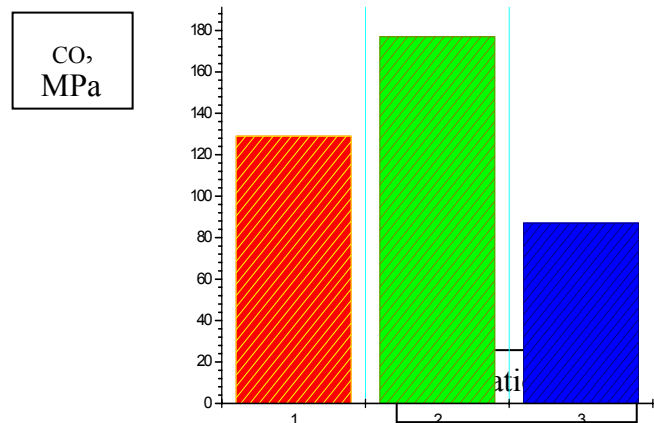
If before flange welding the mean stress made  $-97$  MPa, then after flanges were welded in, a change in the stress polarity into tensile stresses was observed:  $+665$  MPa, and after thermal processing almost five-fold decrease in tensile stresses was noted:  $+138$  MPa.

The most stable operation is thermal processing (the minimal reference sample deviation =  $87$  MPa), and the most unstable – welding in flanges ( $\text{CO} = 177$  MPa).

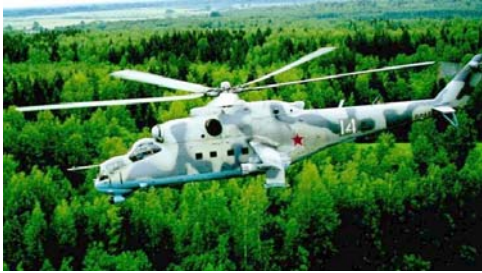
**Object of check** - seven main rotor blades of MI-8 helicopter made of alloy AVT-1. In this instance, vanes 0, 1, 2, 3, 4, 5, 6 had operation time of 370, 795, 795, 1588, 1588, 1588 hrs, respectively.

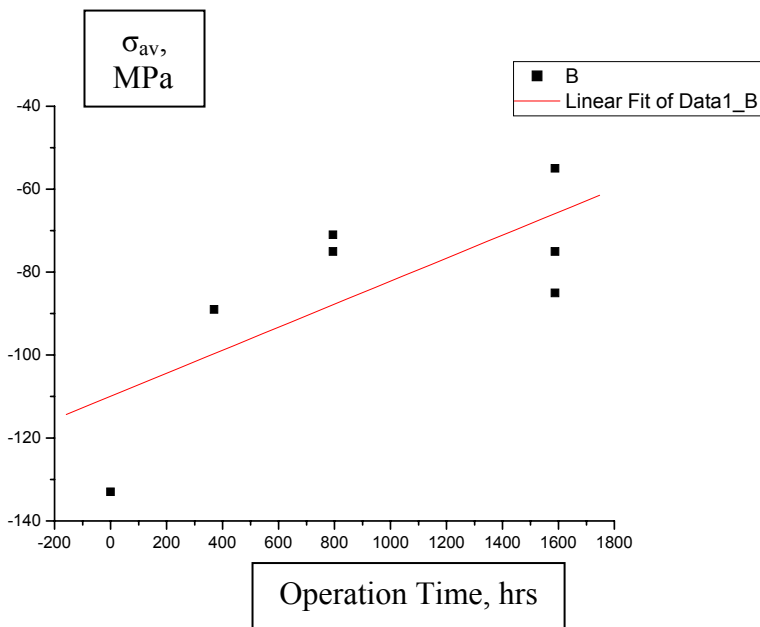
Linear approximation of the dependence between the blade mean stress and operation time is shown on the figure. It follows from the obtained functional dependence that operation of the helicopter main rotor blades leads to a shift of the original level of compressing residual stresses towards tension.

For all checked blades on the lower berth of longeron, strongly expressed heterogeneity of residual stresses lengthwise was observed, characterized by existence of areas where the residual stresses had undergone significant changes compared to original (vane 0). For each blade, the mean stress value along the length  $\sigma_{av}$  was determined (see the table). The resulting from correlation

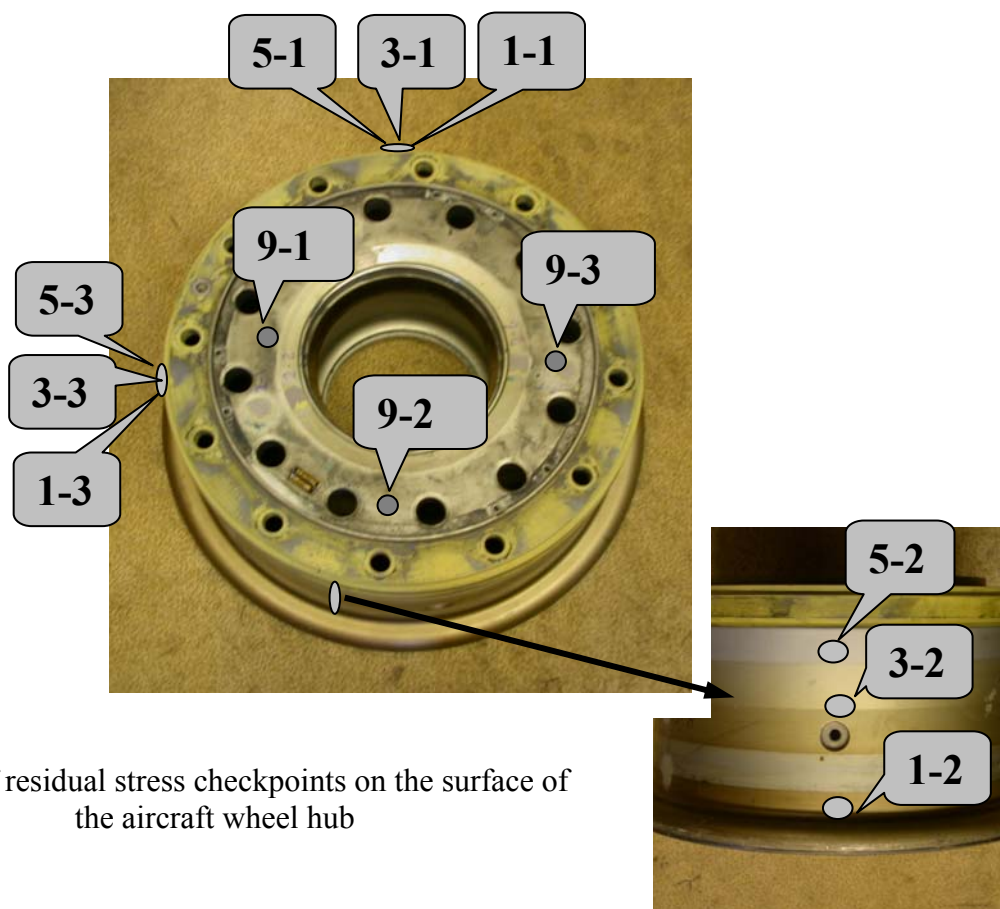
Scheme of residual stress checkpoints on the surface of the aircraft wheel hub

**Check points** – are depicted on the scheme.

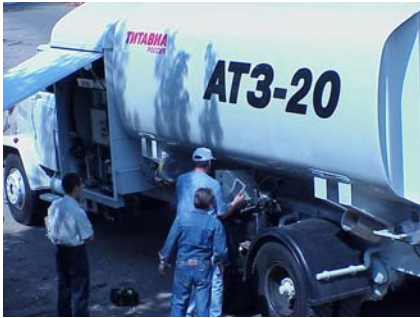
During measurement of refueller tank ARZ-20

**Purpose of Check** was to determine stress condition of empty refueller tank, and when the tank was filled – mean effective stress.

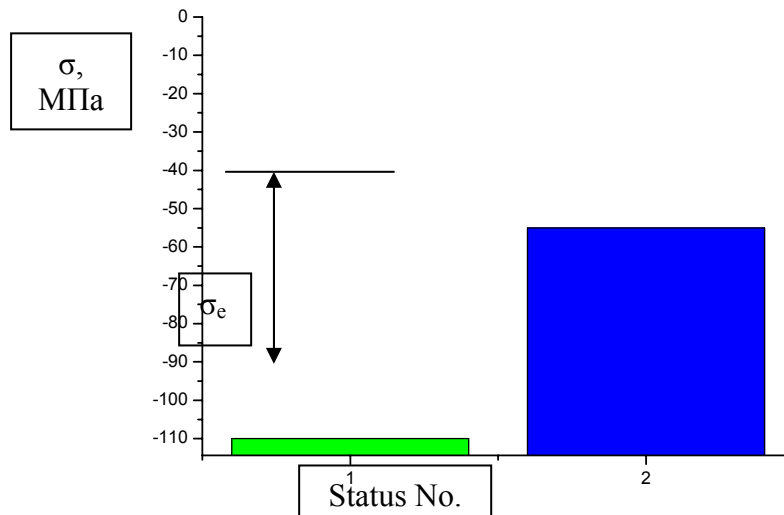
Before the tank was filled (status 1), mean stress made –110 MPa (mean standard sample deviation = 20 MPa), after it was filled (status 2): -55 MPa (mean standard sample deviation = 90 MPa). Consequently, the mean stress  $\sigma_e$  when the refueller tank is filled equals to +45 MPa (see the diagram).

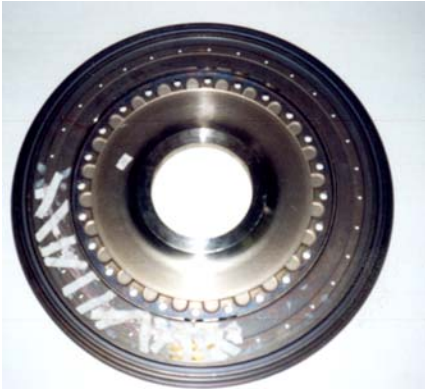
## Application 5. Stress Condition Check of Chromium-Nickel Alloy Disks of Gas Turbine Engine

**Object of check** – six disks made of chromium-nickel alloy.

**Purpose of check** – was to determine influence of operation time on the stressed condition of strengthened disk surface.

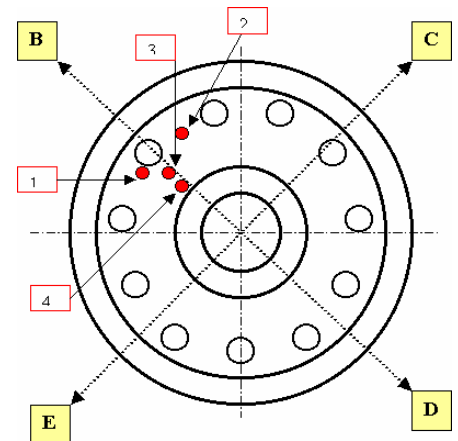
directions, on the disk part strengthened by surface plastic deformation, four measurements were performed: checkpoint 1 – next to the hole, 2 – between the holes, 3 – under the hole, 4 – under the hole, closer to the collar (see the schematic).

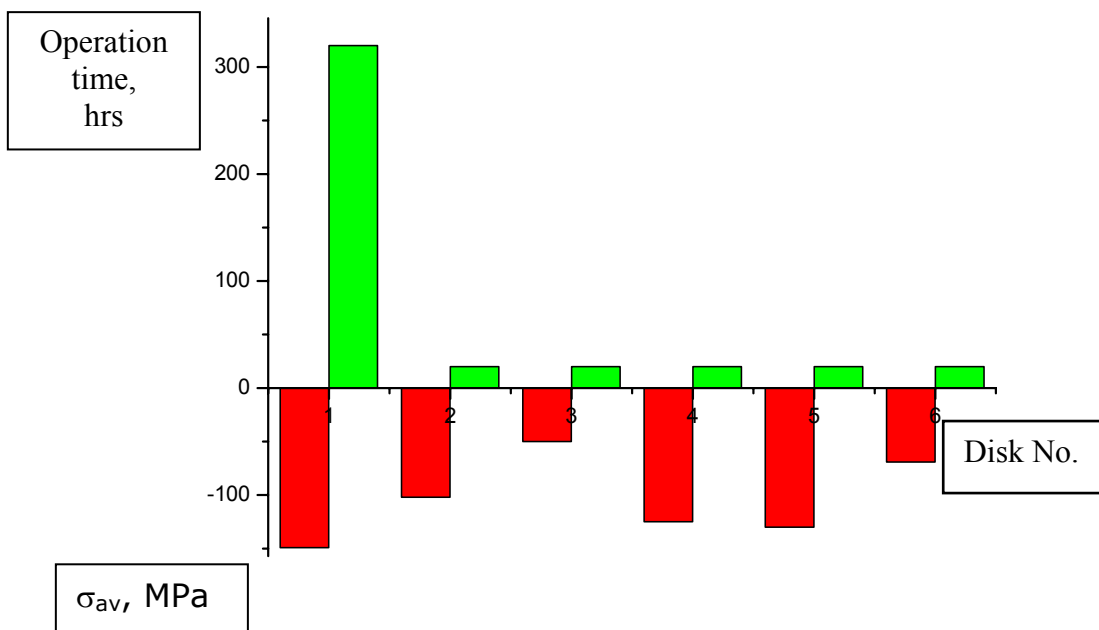
Residual stresses in disk checkpoints are very scattered both in terms of value and in terms of polarity: from  $-520$  MPa to  $+200$  MPa. This evidences large instability of the technological operation of disk flat strengthening.

The results obtained are given on the diagram. One can see that the first disk has the highest level of compressive stresses at the comparatively longest operation time while other disks at minimum operation time have the least level of compressive stresses. Consequently, depending on the quality of surface strengthening operation, the operation time affects differently on the change in the residual stresses level.

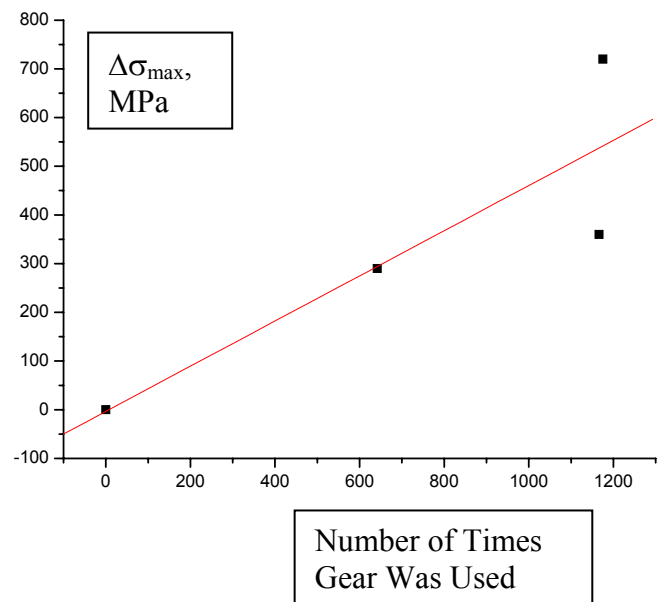
The results obtained are given in the table. Correlation analysis between the stress condition of landing gear and its operation time shows good correlation between  $\Delta\sigma_{max}$  and number of times the gear was used (Pearson coefficient  $r$  equals to 0.73). Linear approximation of  $\Delta\sigma_{max}$  dependence on operation time is shown on the figure. It follows from the resultant functional dependence that landing gear operation leads to a shift of the original level of residual stresses towards tension.

Gear No.	$\Delta\sigma_{max}$ , MPa	Number of Times Gear Was Used	$r$
1	0	0	0,87
2	290	642	
3	360	1166	
4	720	1175

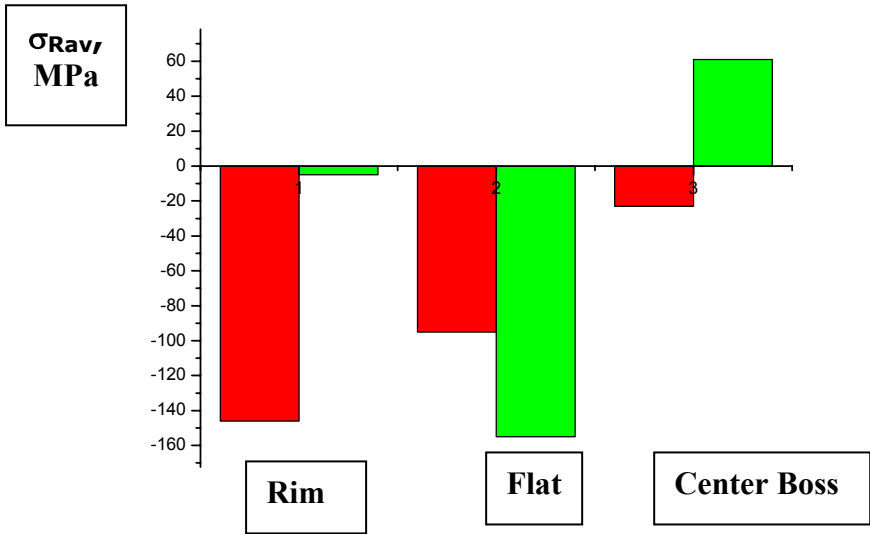
Diagram of Residual  
Stresses Level On Different  
Wheel Sides

The results obtained are given on the diagram. On the diagram, red color marks residual stresses on the inner side, green color – on the outer side. On the inner side of the rim, rather large compressing stresses only are effective; on the outer side, the residual stresses are practically absent. On the flat, compressive residual stresses are higher on the outer side. On the center boss, the residual stresses of compression on the inner side and of tension on the outer side are observed.

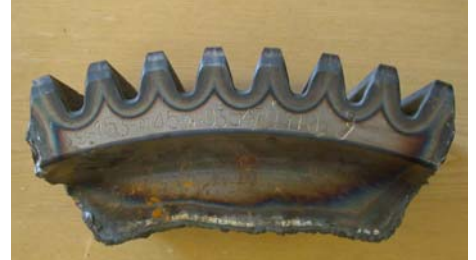
**Object of check** – a fragment of the locomotive pinion made of steel 45XH (Lyublino Foundry Mechanics Factory).

**Purpose of check** – was to assess the possibility of nondestructive quality control of pinions' thermal processing based on residual stresses.

One can see from the results obtained that all radial residual stresses  $\sigma_y$  feature the nature of compression. At that, significant variation is observed: from -1544 MPa to -16 MPa.

The situation with tangential residual stresses  $\sigma_x$  is much worse: together with effective stresses they are responsible for crack formation at the teeth basis. There, along with compressive stresses, there are zones with tensile residual stresses as well. The variation in the data obtained is even greater than for residual stresses: from -574 MPa to +906 MPa. The variation in value obtained (1480 MPa) is comparable to the elastic limit of steel 45XH.

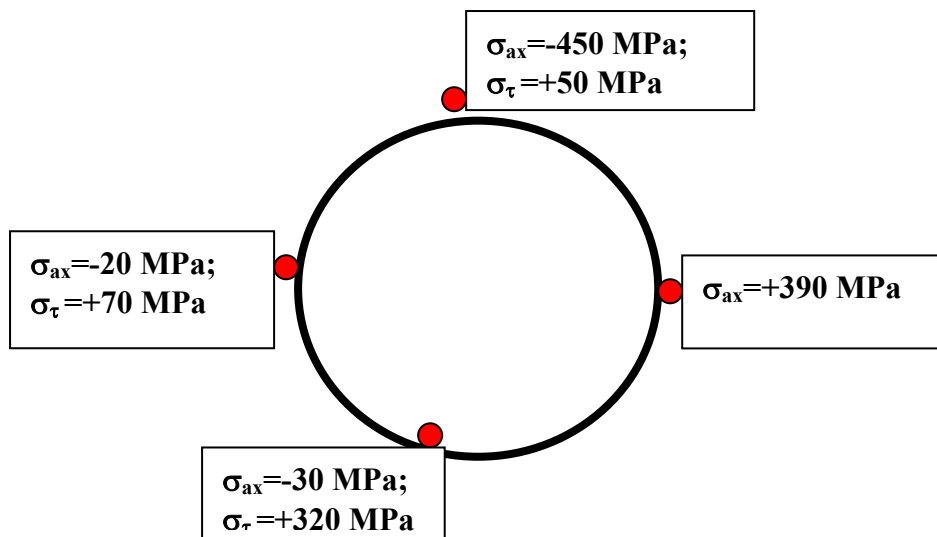
The results obtained for residual stresses in axial ( $\sigma_{ax}$ ) and tangential ( $\sigma_\tau$ ) directions in different weld joint checkpoints are given on the figure. The work done showed the possibility of nondestructive check of weld joints in nuclear power plant environment using portable x-ray diffractometer «Rikor»

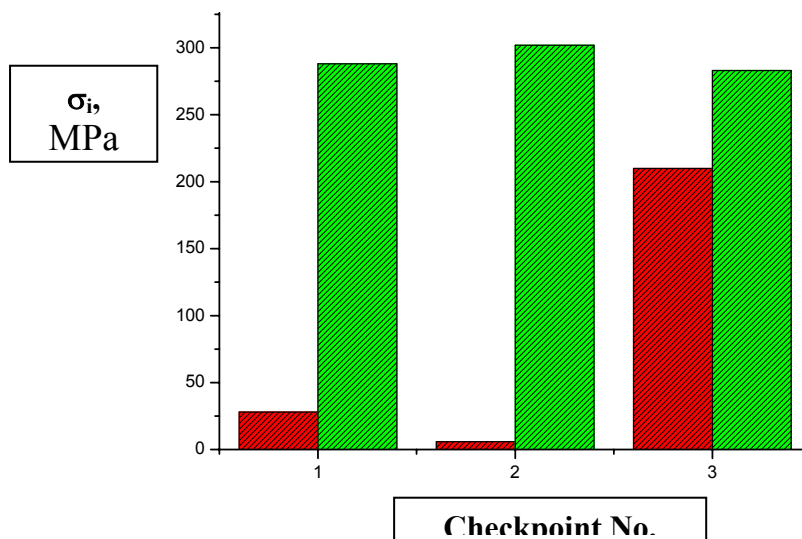
The diagram represents residual stresses read from checkpoints 1...3 in case of 0 years operation time (red color), and 17 years operation time (green color). The data obtained show that the original level of tensile residual stresses in the said checkpoints considerably grows after seventeen years of operation, to a greater extend – in the nearest to the weld seam checkpoint, and to a lesser extend – in the third checkpoint.

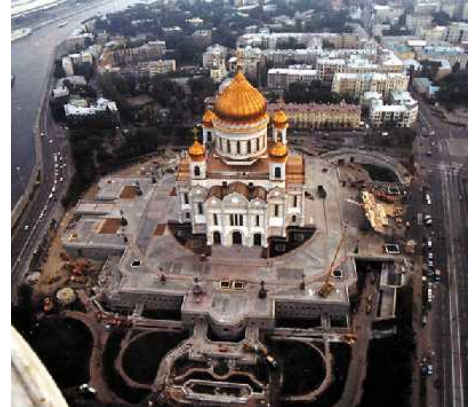
**Check Points** – column base.

### Results Obtained

Check has revealed that three columns were loaded equally. The fourth column was somewhat unloaded as regards other columns.

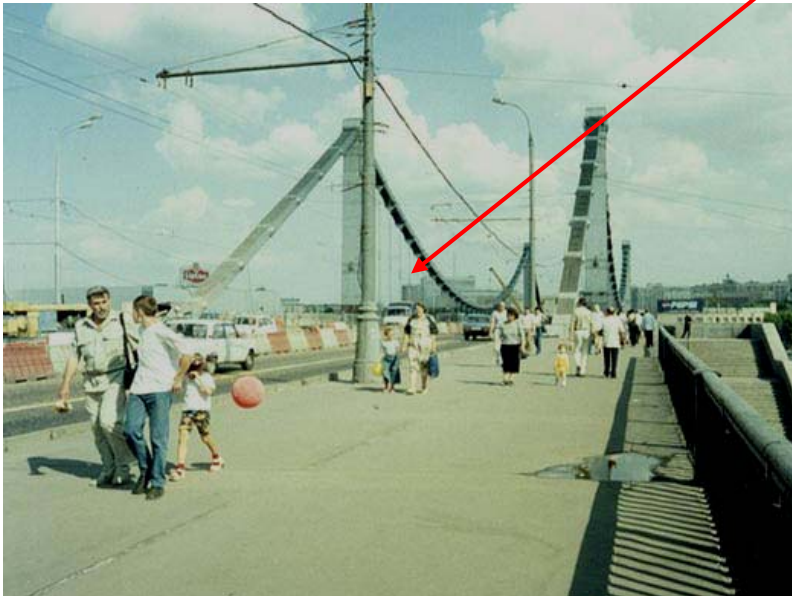
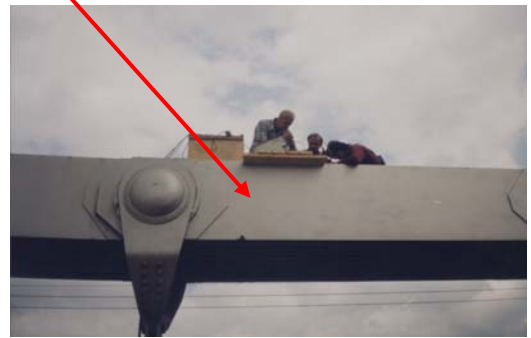
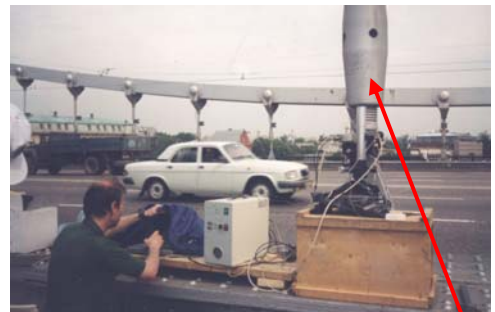
### Load-Bearing Chain

## The Krymsky Bridge Check

**Stress check of the load-bearing chains, ties of the Krymsky Bridge in Moscow revealed the necessity of repair operations.**

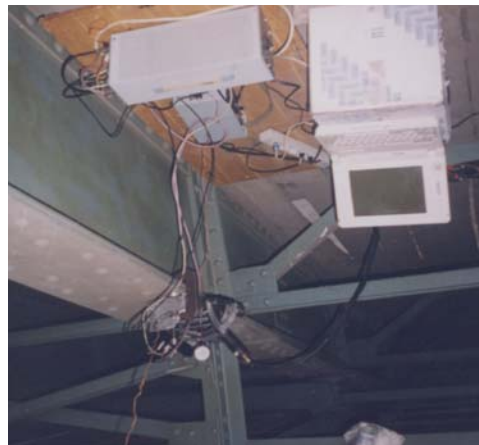
## The Borodinsky Bridge Check

**Purpose of check** – was to assess stress condition of the structural elements of bridges.

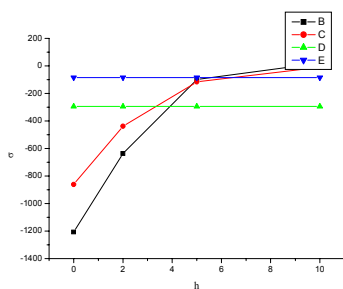
Fig.2

Almost one-hundred percent correspondence between two methods by mean residual stress values is noted at a depth of four microns (according to Davidenkov:-225 MPa, according to XRD method:-229 MPa). Since for alloy EP741, the depth of half x-rays attenuation varies within 4-6 microns, the match of the results obtained by the two methods, based on the mean value, can be assessed as ideal.

Thereafter, samples were handed over to N.S. Merkulova, Salut NPO, for stress analysis following the Davidenkov method using POVKON TENZOR plant. The resulting values of stresses along thickness  $h$  of the samples obtained at the POVKON TENZOR plant P (Davidenkov method) are given on fig.2 (sample 1) and fig. 3 (sample 2). Straight lines D and E limit the interval of residual stress values obtained using « Rikor » Series instrument. Curves B and C show distribution of residual stresses in the surface in case of consecutive removal with etching of the previous surface layer, which distribution was obtained following the Davidenkov method.

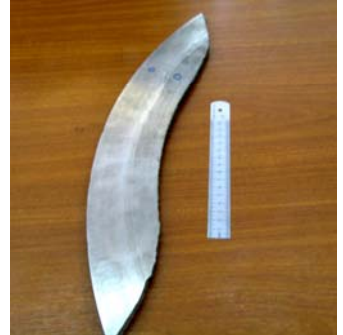
**Checkpoints** – the first checkpoint is on the working surface of the iron forming, the second – in the surface layer of white cast iron close to the working surface, the third one – in the gray cast iron layer far from the working surface.

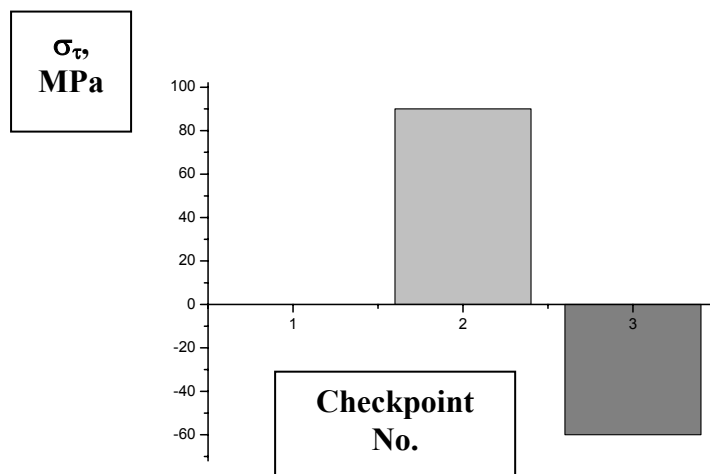
In the tangential direction, in the surface layer of white cast iron (checkpoint 2), tensile stress was observed (+90 MPa); further, in the gray cast iron layer (checkpoint 3), there were compressive stresses (-60MPa).

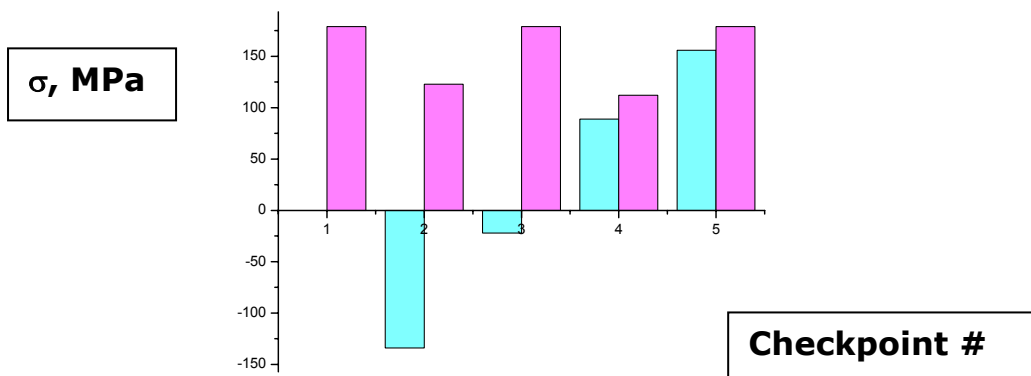
After stress condition inspection of the crane body after repair, the body was checked in the course of its testing by internal pressure of 75 **Atm**. The residual stresses in checkpoints at the time of testing are marked with purple color in the bar chart below.

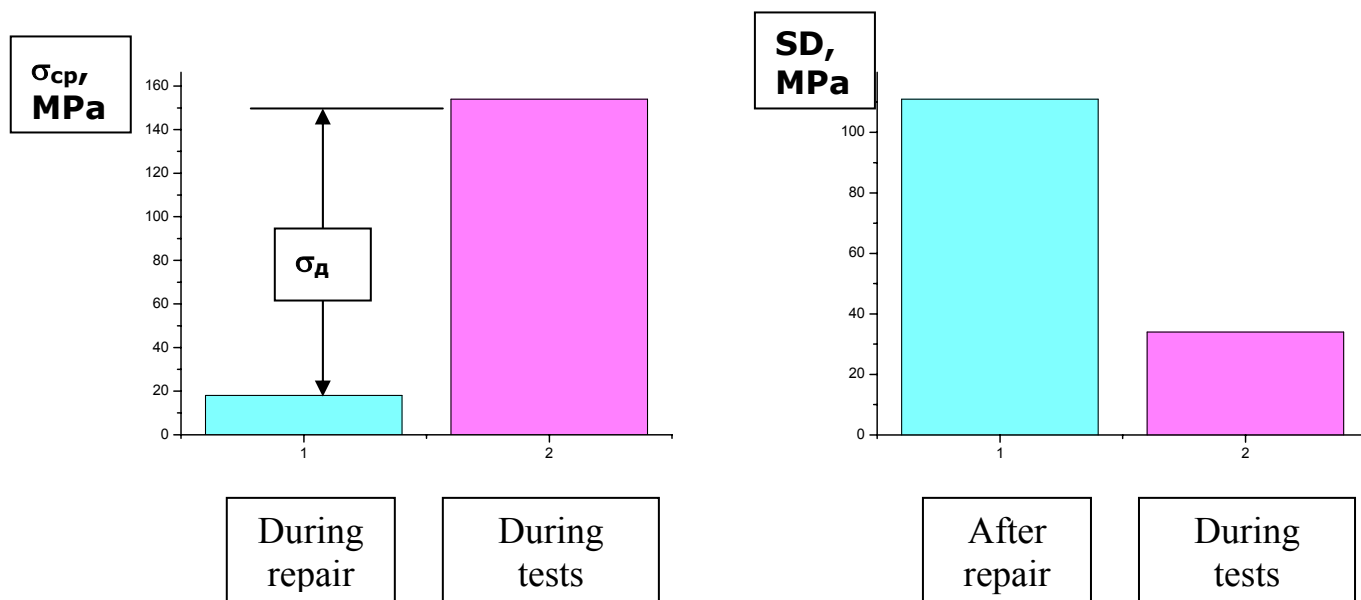
Based on the data obtained, mean stresses  $\sigma_{av}$  and standard deviation after repair and during tests were found out (see the bar charts below см. нижние гистограммы), which allowed determining mean effective stress  $\sigma_{ef} = 136$  MPa. Under the action of internal pressure, data scattering falls down (see the bar chart of standard deviations SD),

The internal pressure (75 Bar) levels irregularity of the stressed condition in the crane body. The influence of residual stresses' asymmetrical action may be pronounced during operation of this crane, particularly in checkpoint 5.

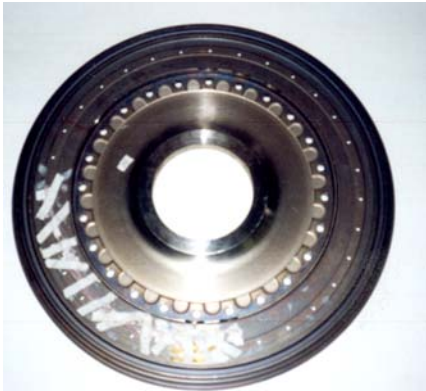
## Application 21. Stress Condition Check of Gas-Turbine Disks Made of Chromium-Nickel Alloy After Assembly

**Object of check** – a disk made of chromium – nickel alloy.

**Purpose of check** – determining stress condition of the disk after assembly

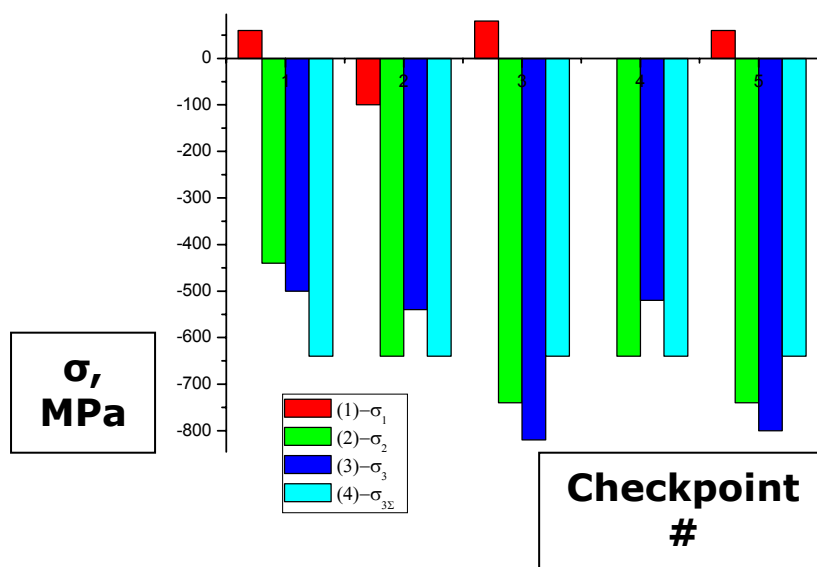
The results obtained are shown on the bar chart. On the bar chart red color marks residual stresses ( $\sigma_1$ ) by checkpoints, green color – stresses after assembly ( $\sigma_2$ ), blue color – assembly stresses ( $\sigma_3$ ) in each checkpoint, light blue color – mean assembly stress ( $\sigma_{3\Sigma}$ ), the standard deviation being 160 MPa. The data obtained demonstrates that none of stresses exceed the elasticity limit of the material:  $\sigma_{0.2} > 900$  MPa, but are characterized by considerable scattering.

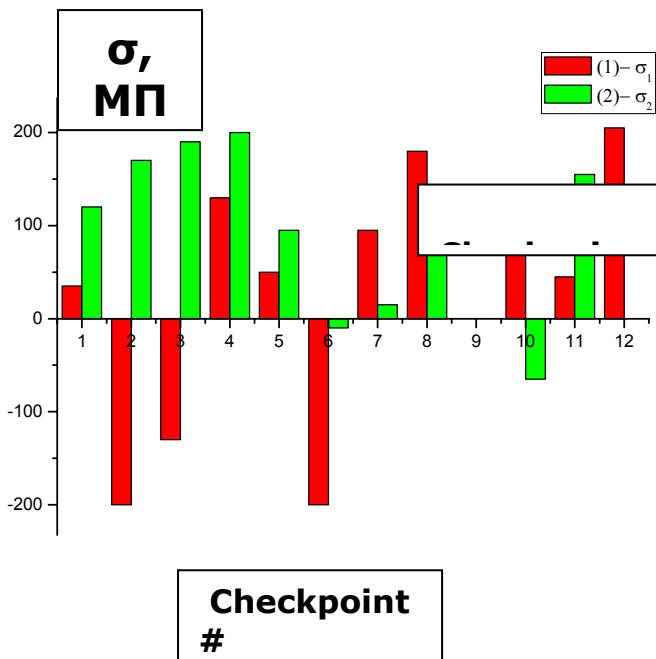
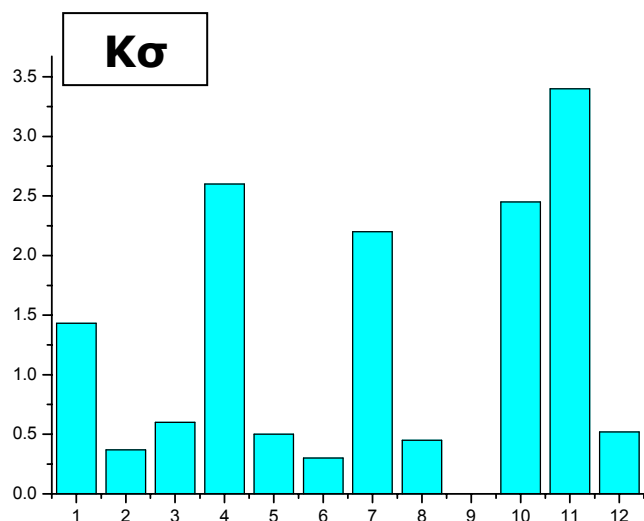
The residual stresses obtained in checkpoints across and along rolling are given on the left bar chart, the stress condition anisotropy index  $K_\sigma$  – on the right. Mean values along directions for the whole sample make  $\sigma_{1cp} = 30$  MPa and  $\sigma_{2av} = 91$  MPa. It is evident from the data presented that stress condition in this sample is characterized by high level of anisotropy.

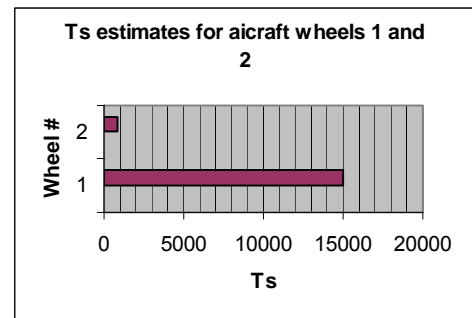
Hub 1 has maximum stress of -190 MPa, hub 2 had the maximum stress of +95 MPa. As a result of calculation, service life time ( $T_s$ ) diagram was plotted. The relative error of ultimate life calculation amounted to 2% approximately.

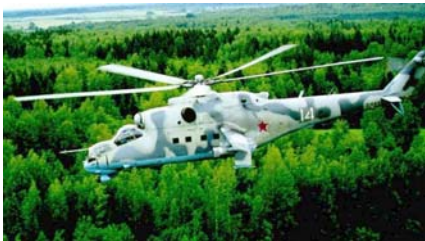
Using portable x-ray diffractometer, six helicopter blades were examined, each having its own operation time. Their design life equals to 2000 hours in flight.

Application of the newly developed method allowed determining  $T_s$  for each blade (fig.4.3 and 4.4). As a result, blade 1 has residual

life time  $T_r = -319$  hours, blade 2 has  $T_r = 105$  hours, blade 3 has  $T_r = -141$  hours, blade 4 has  $T_r = 4897$  hours, blade 5 has  $T_r = 1922$  hours, blade 6 has  $T_r = 941$  hours.
